Manhole Inspection Summary

Manhole # S35UU_005MH

Insp Date: 1/11/07 12:15 PM

Location Address: **346 BARCLAY ST**

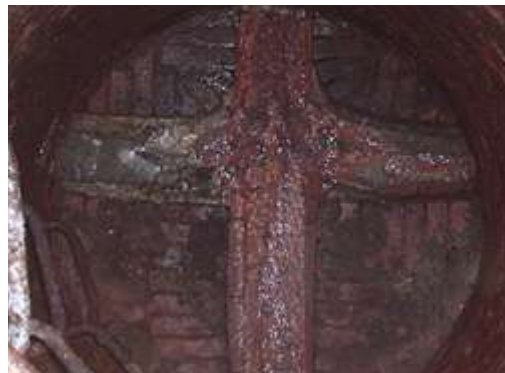
Top View

☐ Parged ☒ **Debris** (not Condition related)

Count: **5** Missing: **0** ☒ **Corroded**

☒ **Evidence Of Surcharge** Depth: **1** (ft.) ☐ Active Surcharge Present

Corroded steps. Evidence of surcharge - Bench debris.

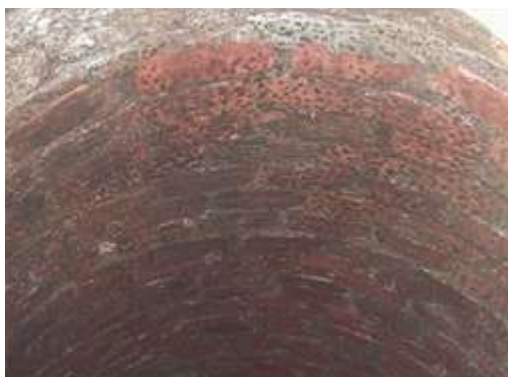
Defect

Infiltration: ☐ None ☒ **Joint** ☐ Cracks ☐ Mortar ☐ Roots ☒ **Wall**

Adjustment infiltration.

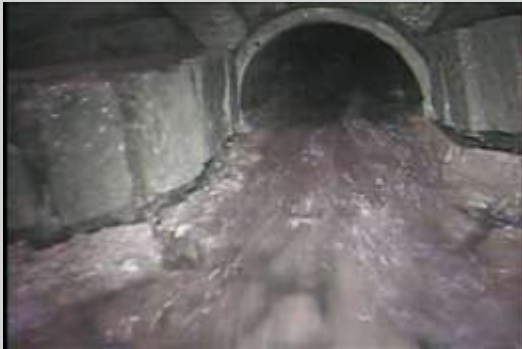
10 in. Circular Gravity Sewer Pipe Out @ 12 O'Clock

Condition: ☐ Sound ☐ Cracked ☐ Root Intrusion ☒ **Deteriorated** ☐ Leaks ☒ **Debris**

Channel deterioration.

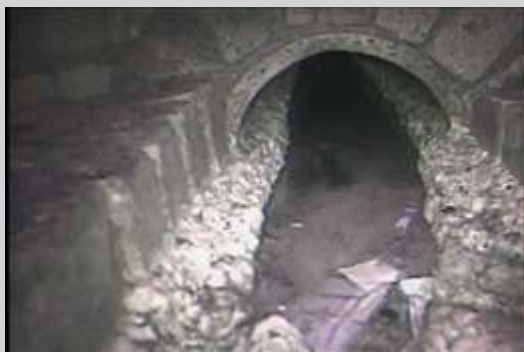
8 in. Circular Gravity Sewer

Channel debris / Grease deposits.

Deposits: ☐ None ☐ Mud ☐ Sludge ☐ Debris ☒ Grease

Silt Depth: **4** (in.) Deposits Extent: **Medium**
